**BITTER ROOT IRRIGATION DISTRICT
MAIN CANAL**

**CANAL LINING DEMONSTRATION PROJECT
Exposed 20-mil Geocomposite
(8-oz geotextile with carbon black - 20-mil Ethyl Vinyl Acetate - 8-oz geotextile)
OCTOBER 15 - 19, 2001**

Jay Swihart and Jack Haynes
November 2002

Test Section BI-1.—

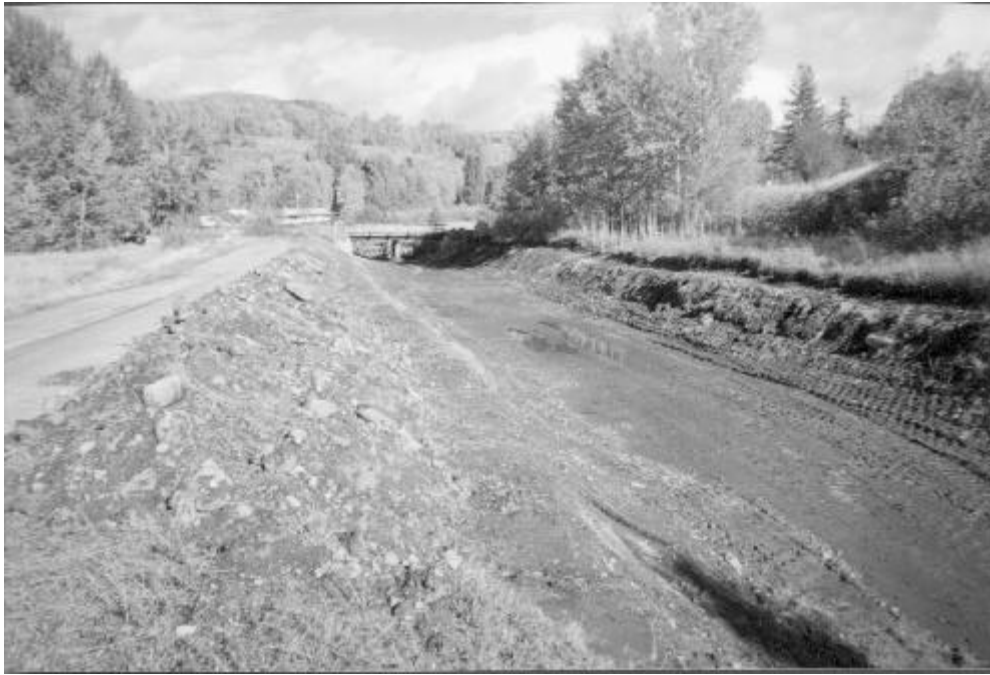
Photo 1.—The District performed extensive subgrade preparation by removing vegetation to 1 foot above the waterline, restoring the 1½:1 side slopes, and cutting a 2- to 3-foot anchor berm on each bank. The downstream section was too wet and was not lined at the time of the photograph.

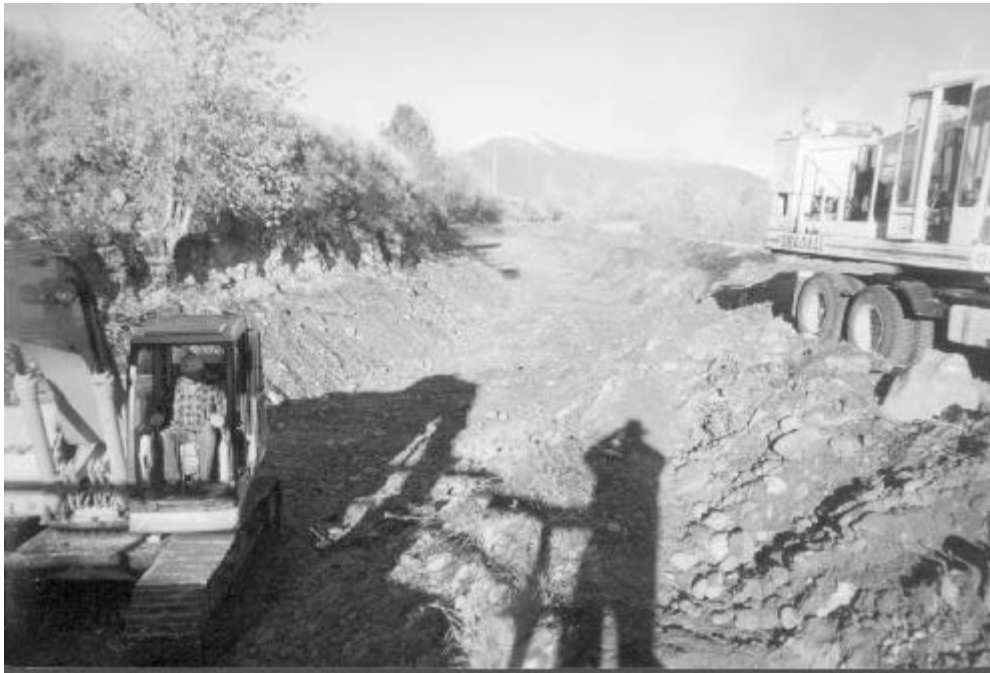
Photograph 2.—Upstream section ready for installation of lining.

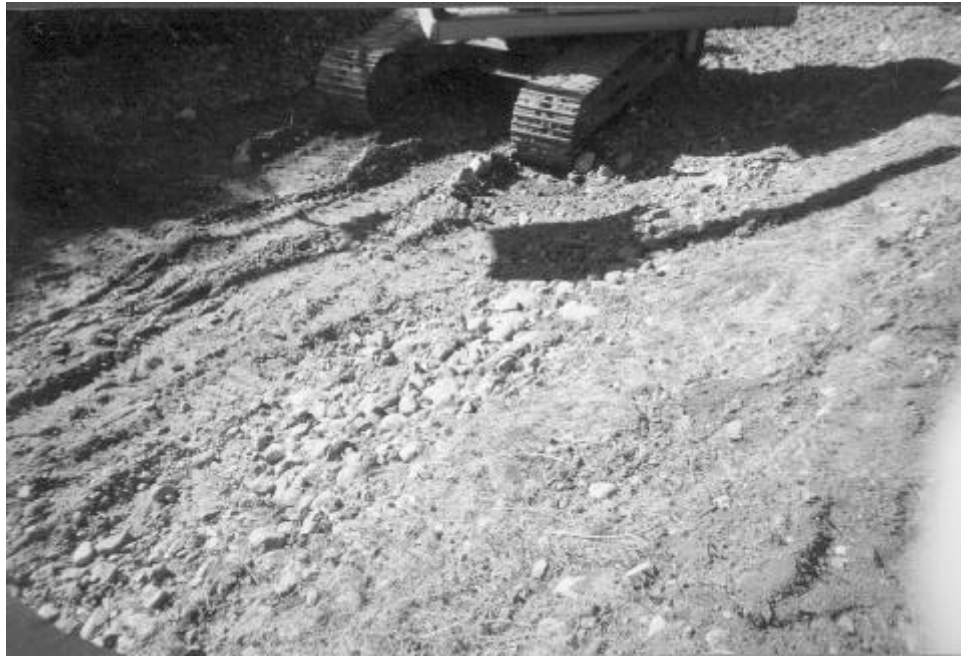
Photograph 3.—The prepared subgrade has large cobbles of up to 6 inches in diameter.

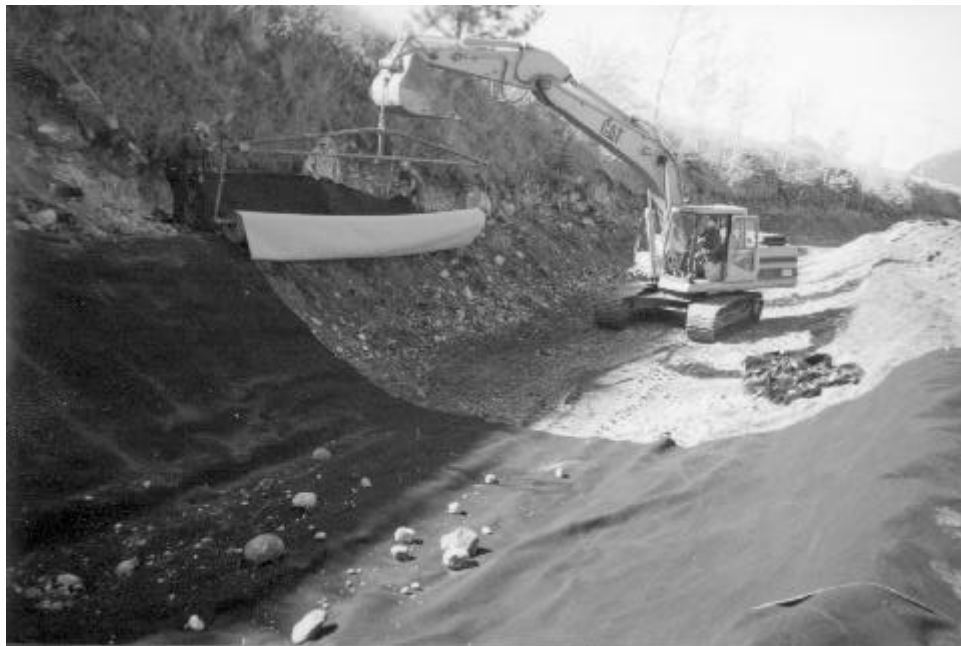
Photograph 4.—Trackhoe operating in the canal invert using a lifting bar to unroll geomembrane across the canal.

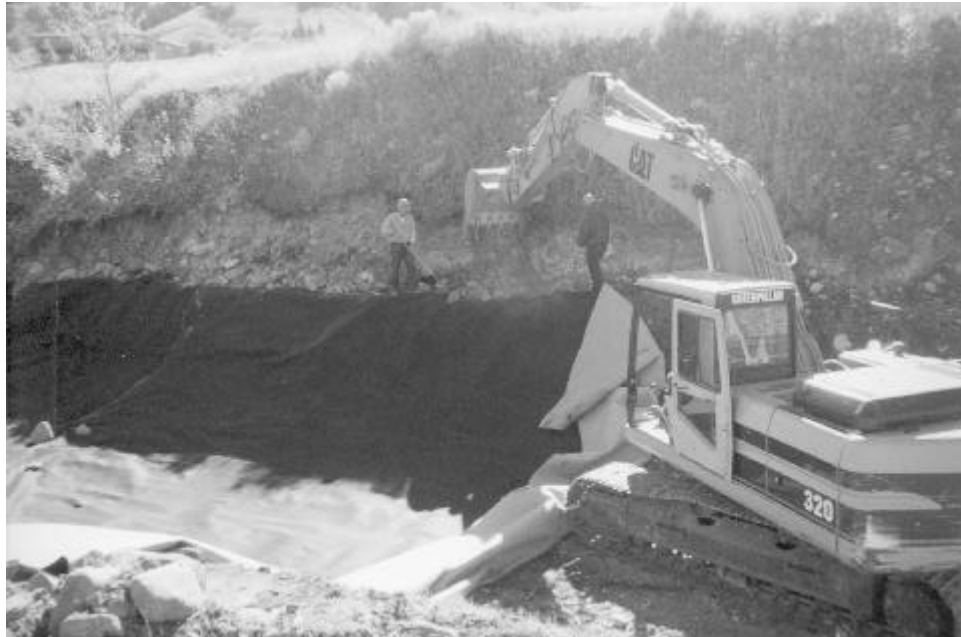
Photograph 5.—Trackhoe pulls down the far bank to cover geomembrane in the anchor berm.

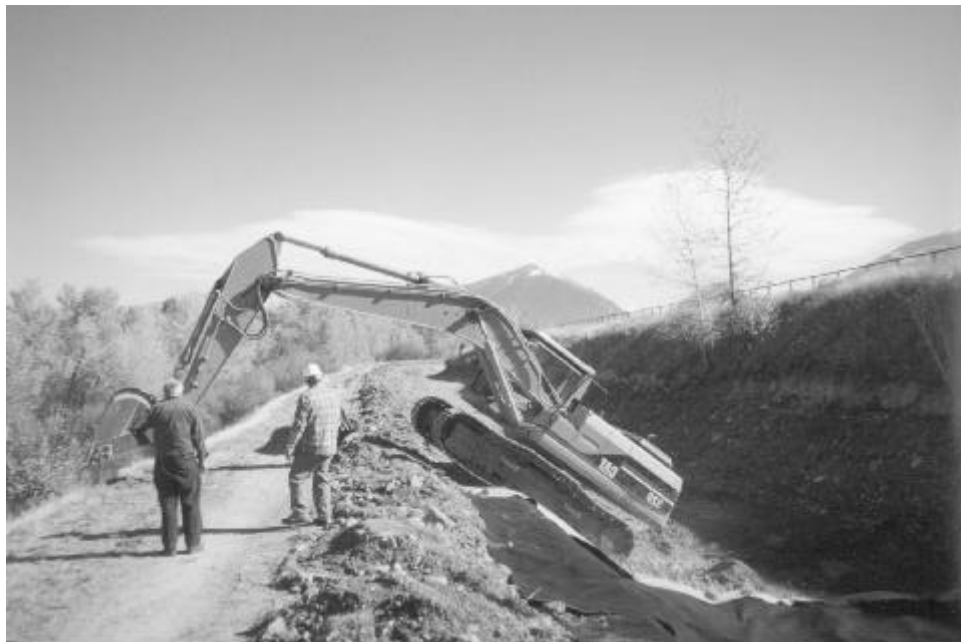
Photograph 6.—At the end of the day, the trackhoe drives up the side slope and out of the canal.

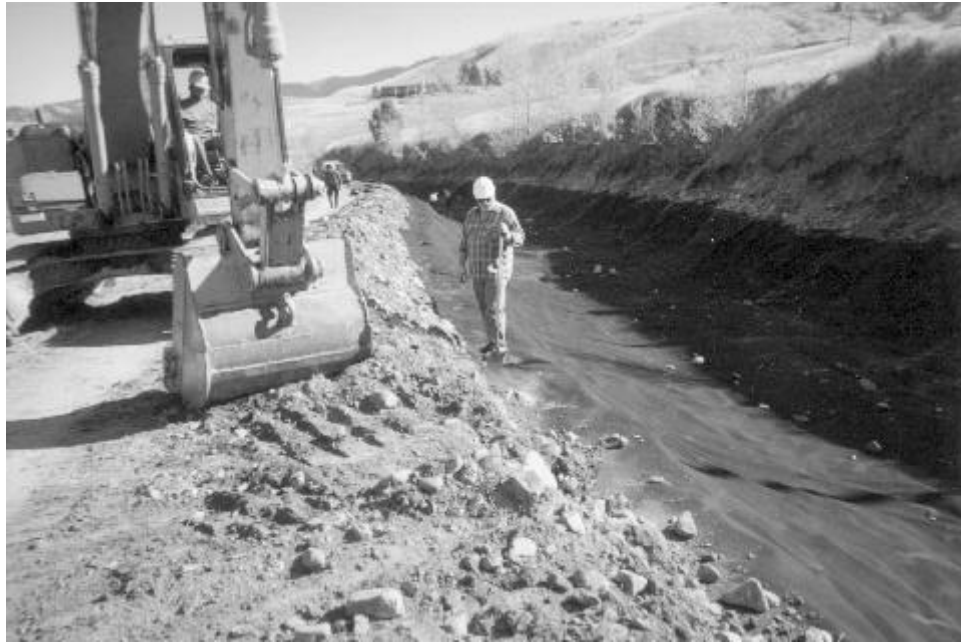
Photograph 7.—Trackhoe prepares to backfill the near anchor berm.

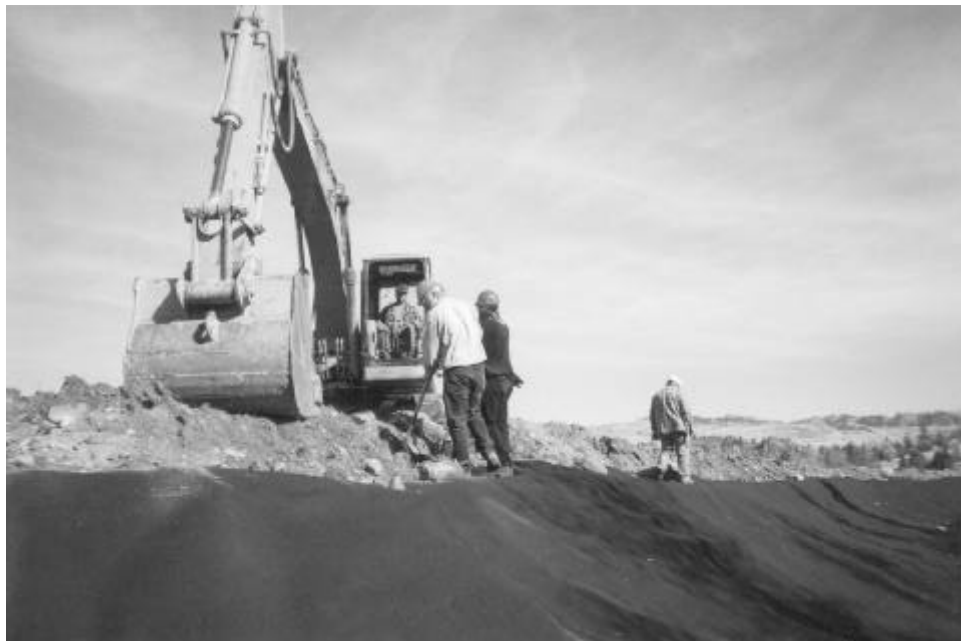
Photograph 8.—Laborers help backfill the near anchor berm.

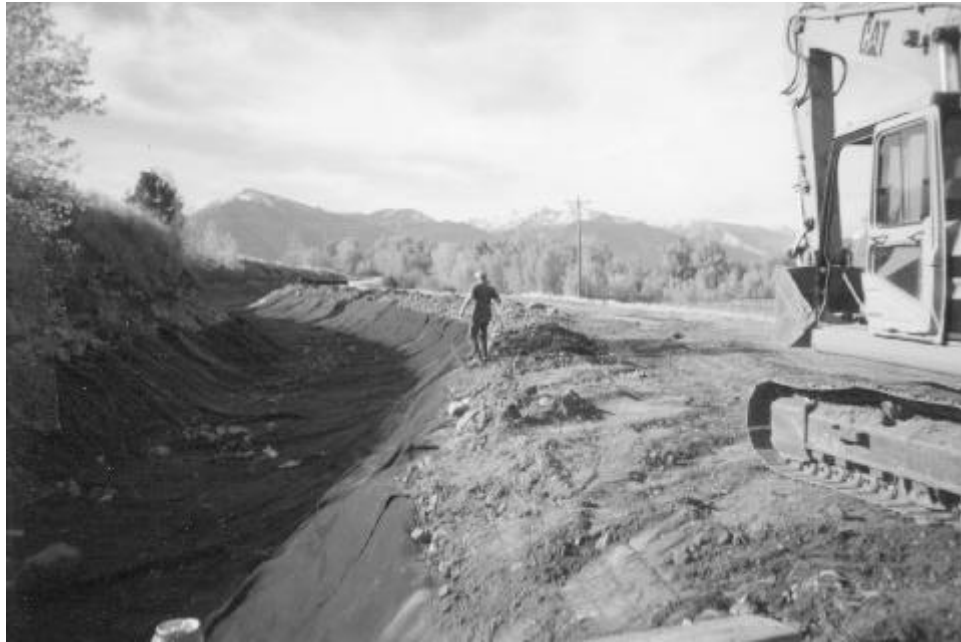
Photograph 9.—Backfill on near anchor berm is complete.

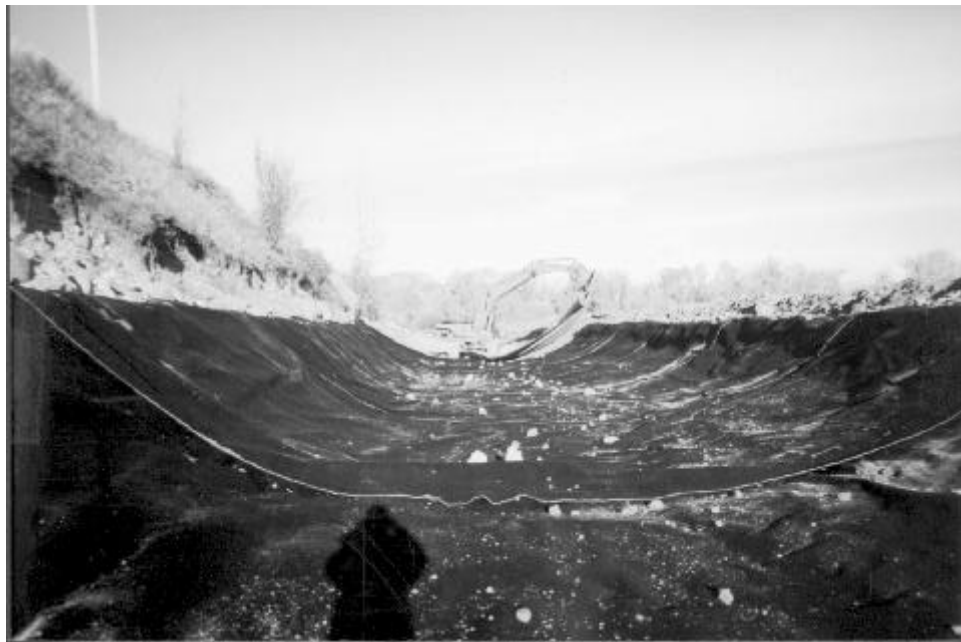
Photograph 10.—Overlapped seams are ready to be sealed. The trackhoe continues to lay geomembrane in the background.

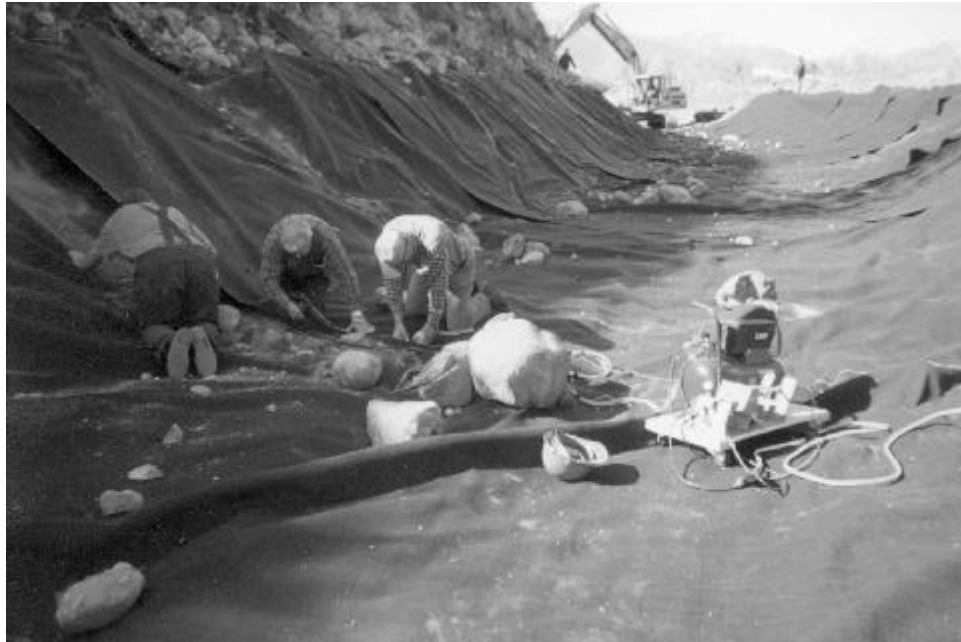
Seaming was quite slow, and the seams were inconsistent (unbonded areas) and relatively weak. The geomembrane manufacturer has a larger gun that places a 1-inch wide bead that would be more suitable for this material. The district switched over to hot roofing tar later in the week. The tar was supplied in a 100-gallon kettle. Hot-tar seaming was more labor intensive and relatively slow because of the time needed for the hot tar to cool and set. A hot-air welder may be another alternative for seaming this material.

Photograph 11.—Three-man crew removes dirt from the seam and seals it with hot glue. Seams need to be held shut until the hot glue cools and sets.

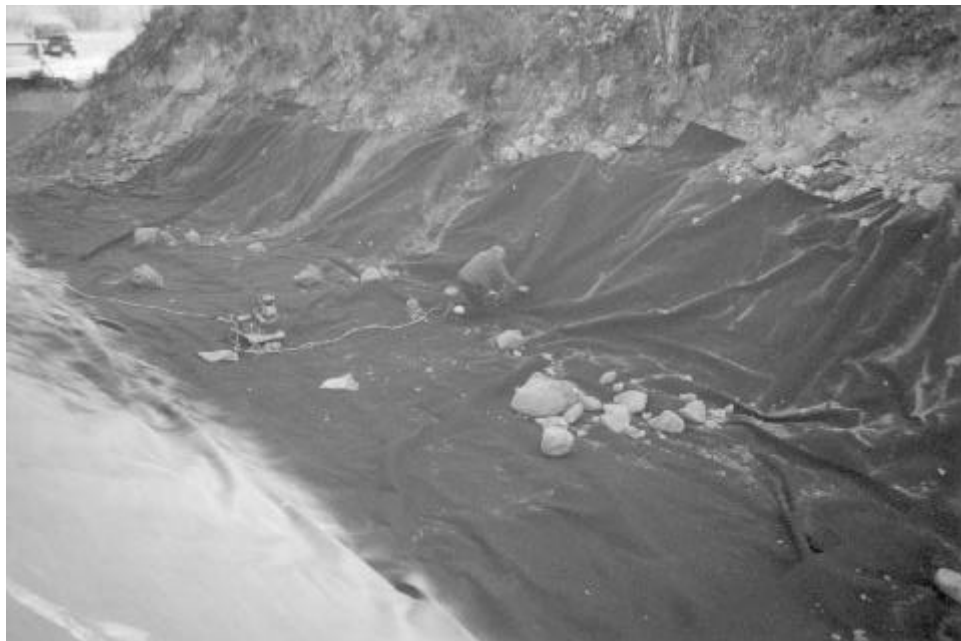
Photograph 12.—Seaming continues.

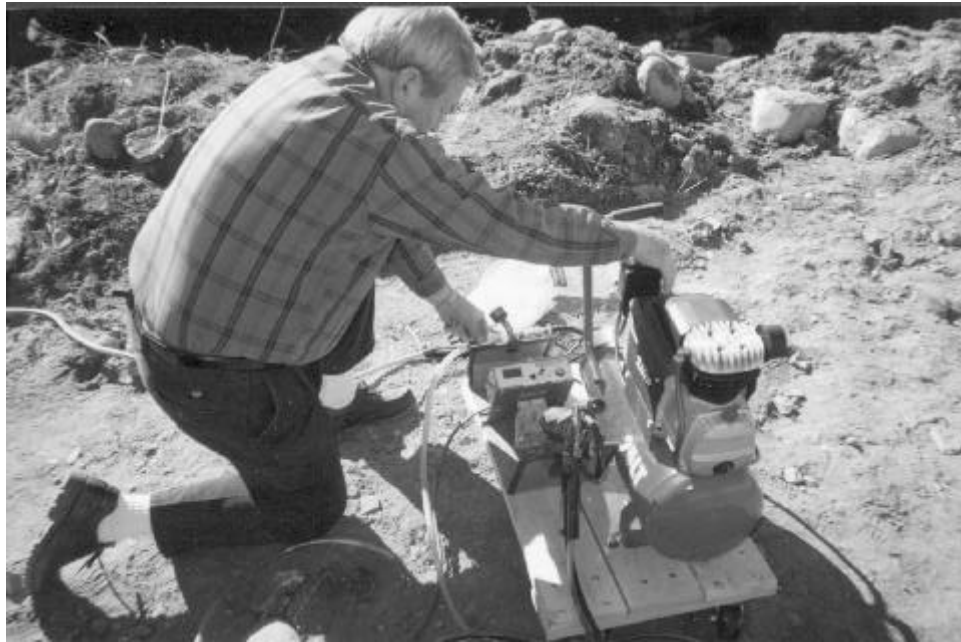
Photograph 13.—Closeup of the industrial hot-glue machine.

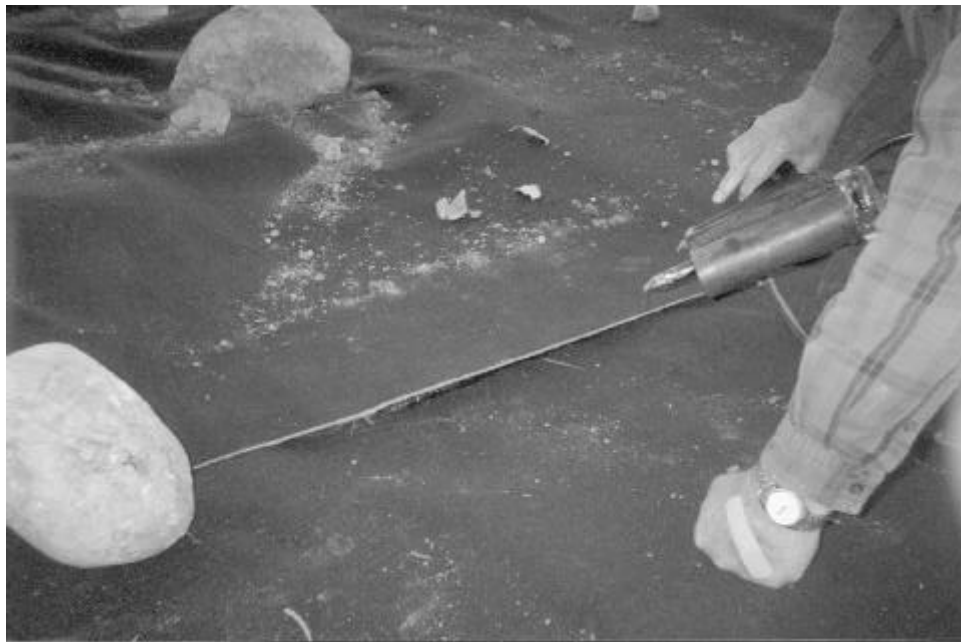
Photograph 14.—Closeup of seam with hot glue. Rock is placed on the seam to hold it together until the hot glue cools and sets.

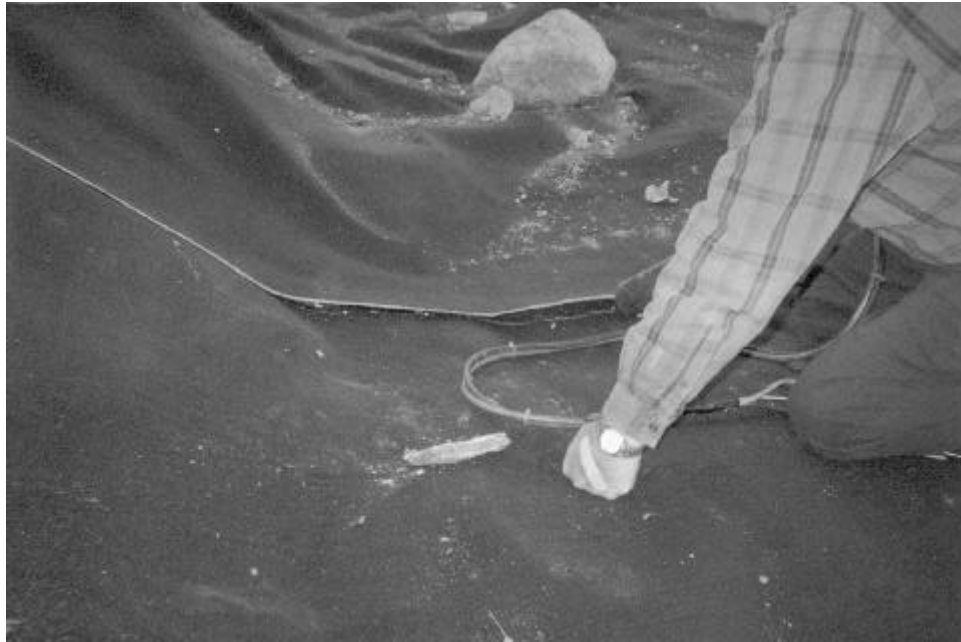
Photograph 15.—Hot glue is extruded into the seam in a ½-inch bead.

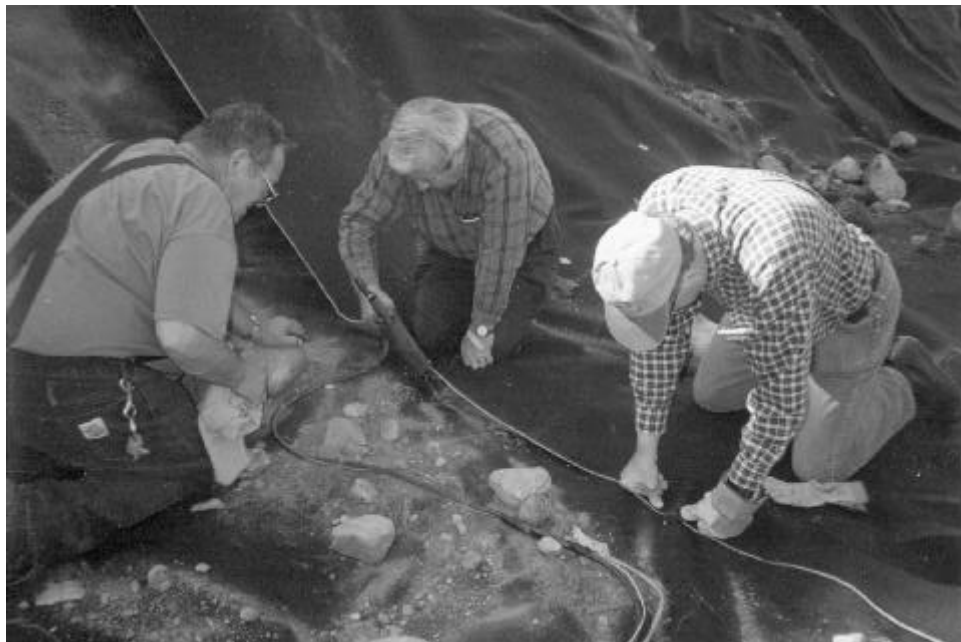
Photograph 16.—Three-man crew cleans the seam (removes loose dirt), applies hot glue, and holds seam shut until the glue cools and sets.

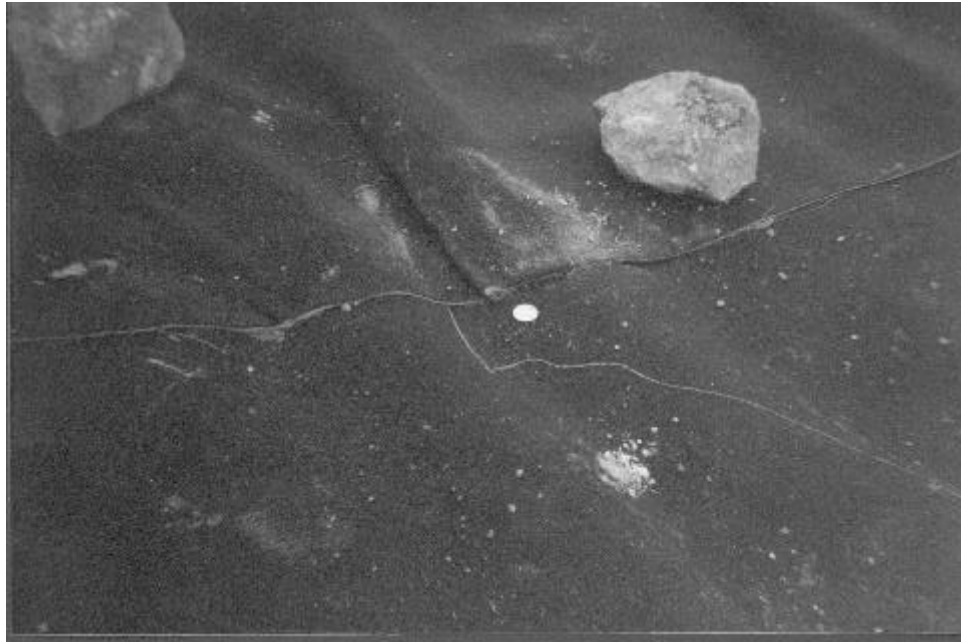
Photograph 17.—Lower portion of Photograph shows factory seam in the upper geotextile. Fishmouth in the seam has been folded over and glued shut.

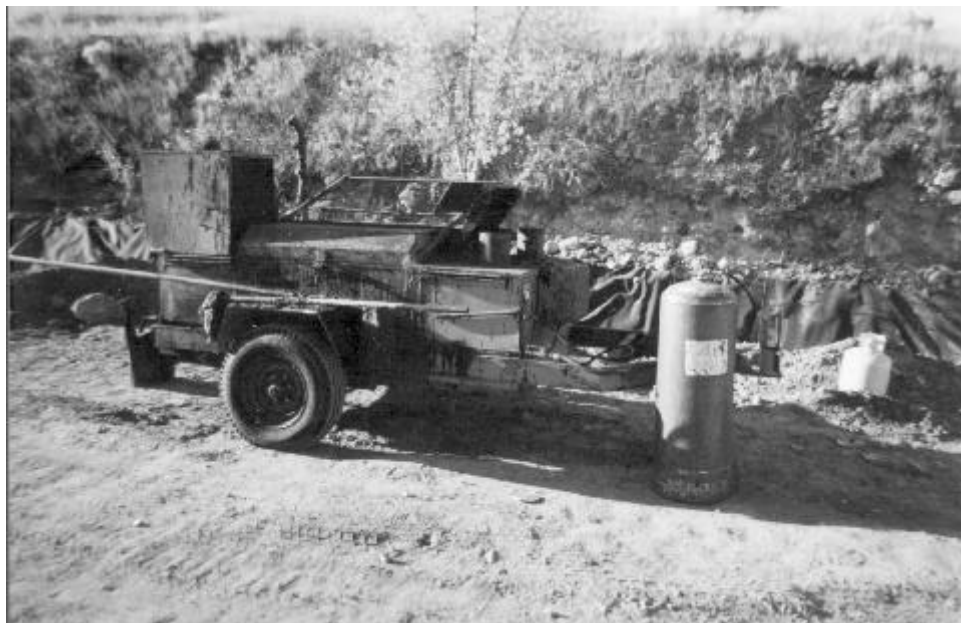
Photograph 18.—Hot tar was also used for seaming. Hot tar was supplied in a 100-gallon propane-fired kettle.

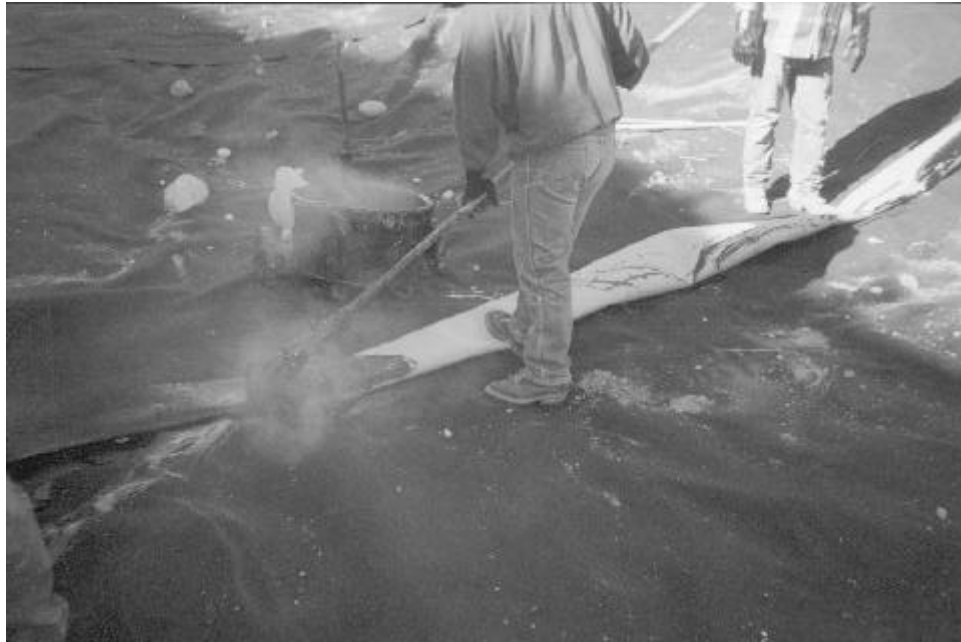
Photograph 19.—Geotextile is folded back, and hot tar is mopped onto both geotextile surfaces.

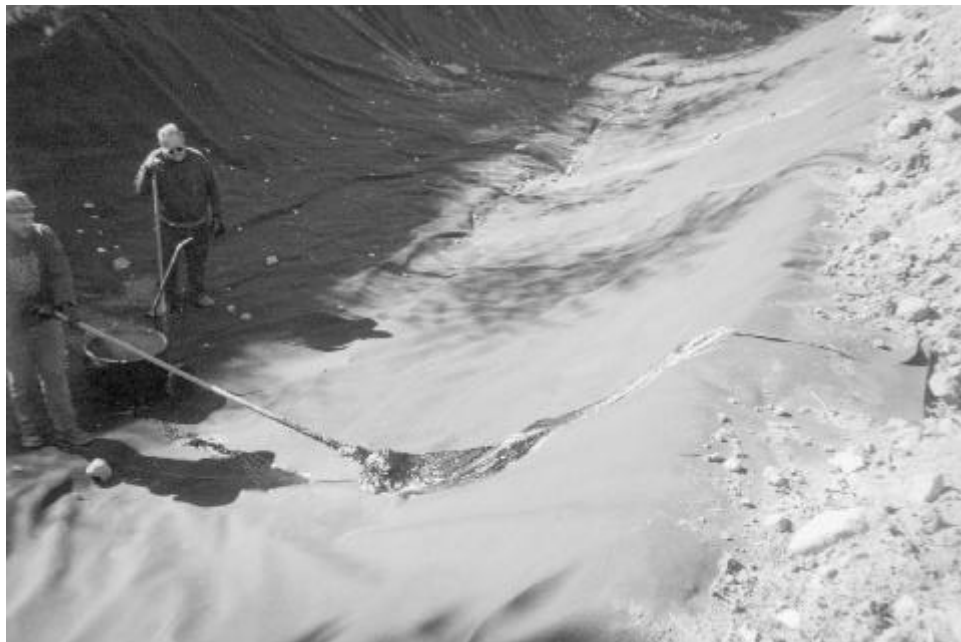
Photograph 20.—Upper geotextile is folded back into position, and the seam edge is buttered with hot tar.

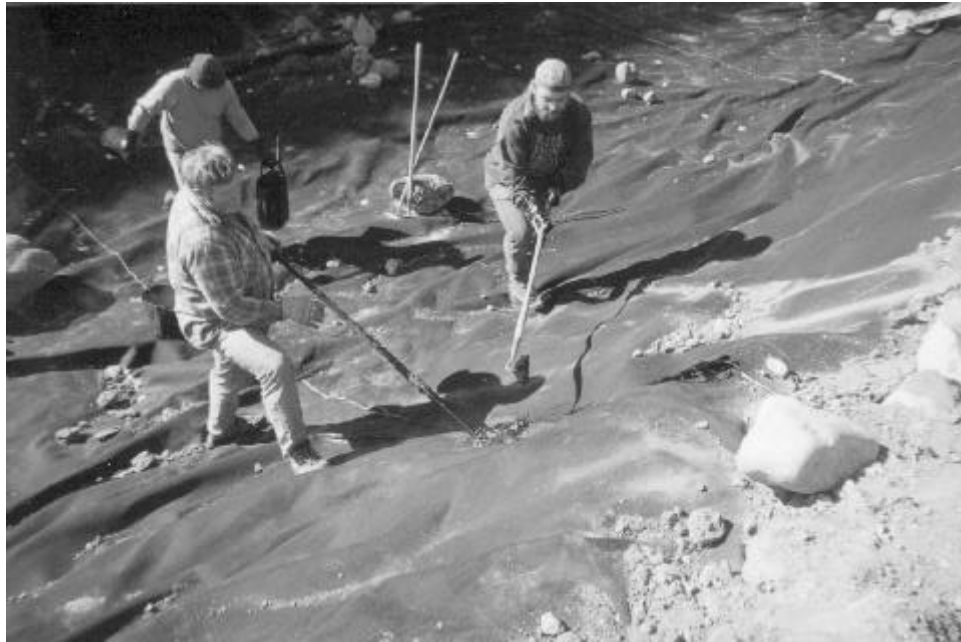
Photograph 21.—Laborer on right uses hoe to hold seam closed while hot tar cools and sets.

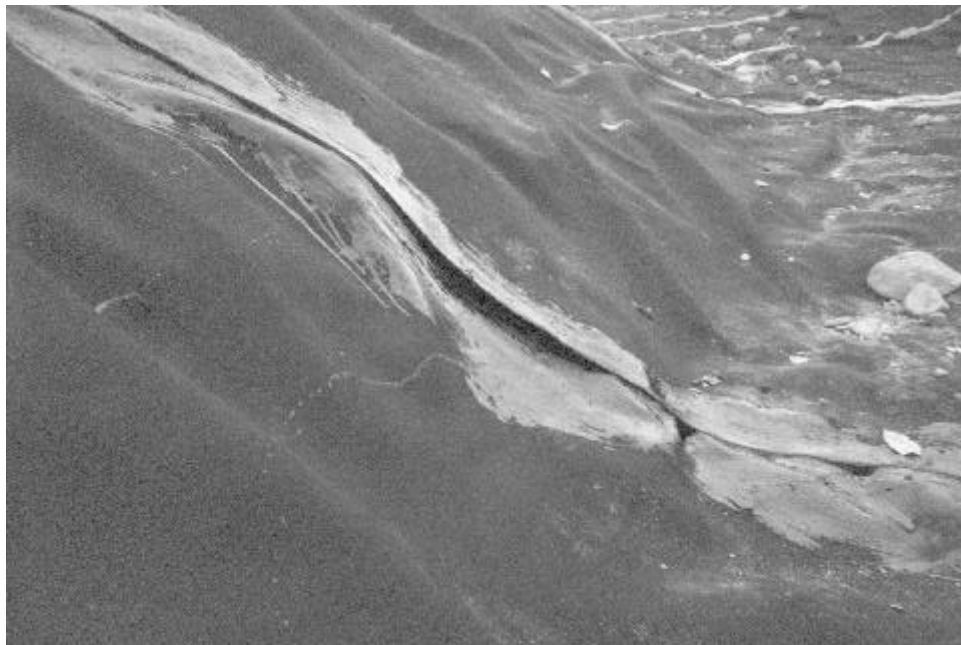
Photograph 22.—Seam with hot tar pops open if not held closed for sufficient time.

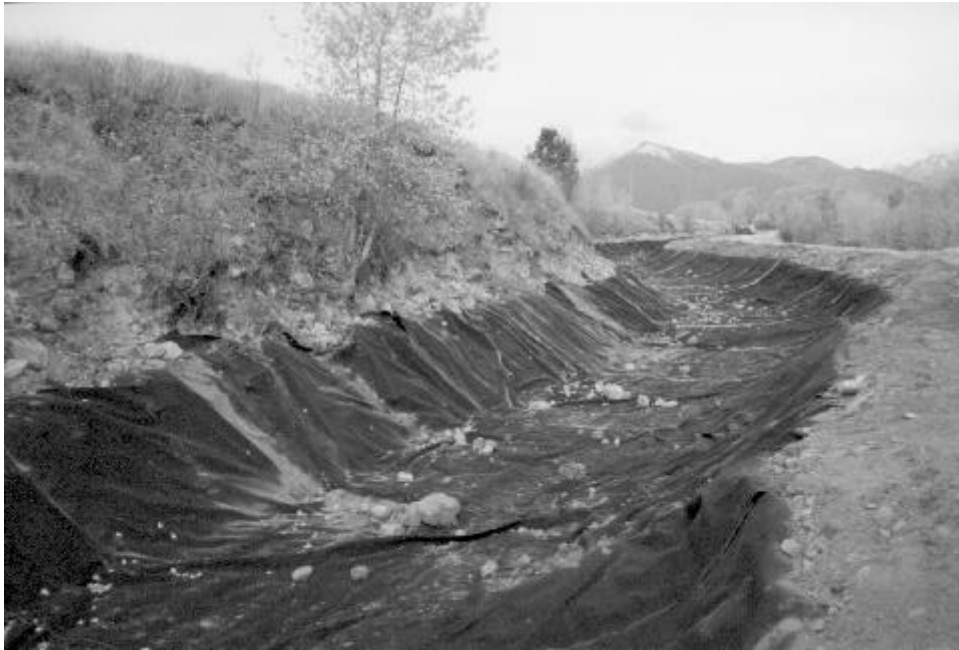
Photograph 23.—Finished installation.

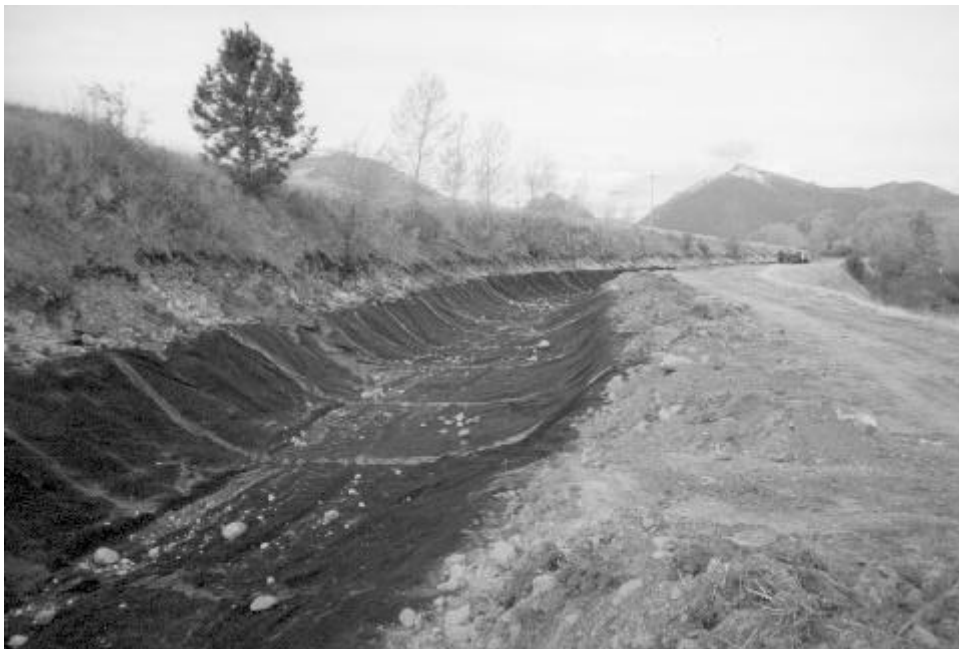
Photograph 24.—Finished installation.
